NTSB: CHECK THOSE FUEL CAPS

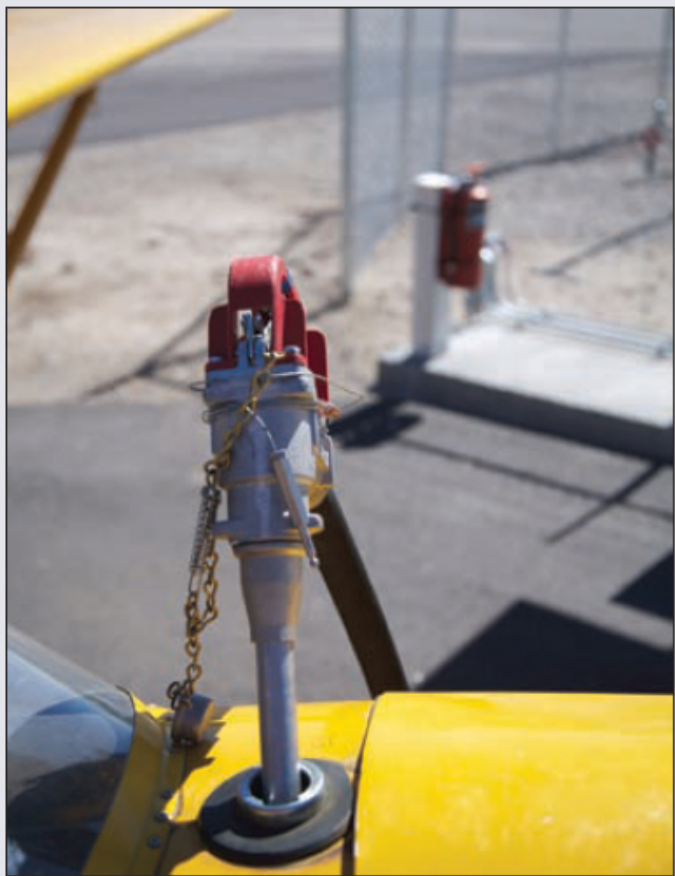
"The airplane had just been fueled by the lineman at the fixed-base operator (FBO), who secured the fuel caps after the service. During the climb after takeoff, the right-wing fuel cap came off of the wing, remaining attached only by the chain. An estimated 11 gallons of fuel was siphoned from the wing before the pilot returned to the airport and taxied back to the FBO. The pilot secured the cap and conducted a visual inspection of the right wing, before attempting to start the engine again.

"The right engine backfired, followed by a loud bang and whoosh sound; flames then rose from the right wing. A post-accident examination of the right wing revealed that the internal blast was a result of the backfire igniting fuel vapors that remained after the siphoning. The blast caused the upper wing skin to expand and separate from the retaining rivets. A soot trail originated at the exhaust pipes and traveled in an aft direction to the trailing edge of the wing.

"Examination of the fuel cap revealed that the outer O-ring was dry and cracked, a washer was missing, the cap leaked under pressure, and that the force required to secure the cap exceeded the manufacturer's specification."
