# Notable Departure Mishaps

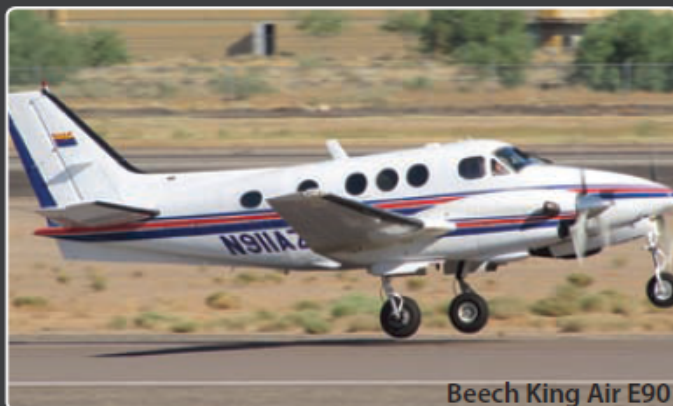
Beech King Air E90

The departure airport was on a plateau, elevation 331 feet msl, with surrounding terrain lower than the runway. After takeoff, the airplane collided with a telephone line 2500 feet

from the departure end of the runway and at 245 feet msl. In the 90 prior days, the pilot had flown 11 hours in actual instrument conditions and logged 20 instrument approaches.

The NTSB: "The pilot's failure to maintain clearance from wires during an instrument takeoff attempt. Contributing to the accident were fog, reduced visibility, and the low ceiling."

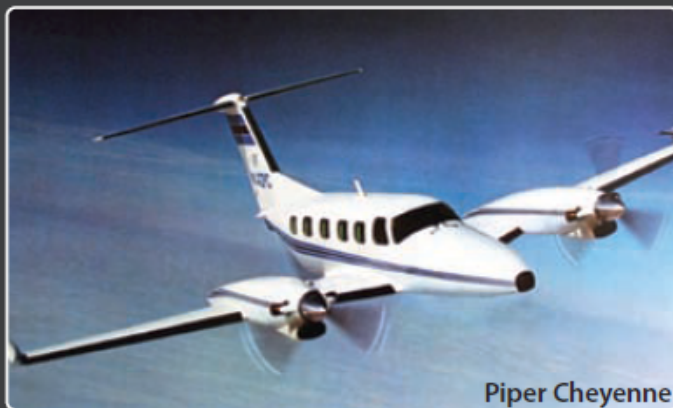
Piper Cheyenne

The 2893-hour instrument-rated private pilot, with over 765 hours in the same make and model, lost control during the initial takeoff climb phase while in IMC. The aircraft impacted terrain approximately 1.7 miles northwest of the departure airport. Evidence at the initial point of impact was consistent with a nose-low attitude and a slight right bank.

The NTSB's probable cause: "The pilot's loss of control while in instrument meteorological conditions during initial takeoff climb. Contributing factors were the prevailing clouds and fog."
