BEA's Safety Recommendations

The BEA has issued 10 new safety recommendations as a result of its ongoing investigation into the loss of AFR447, in four broad categories:

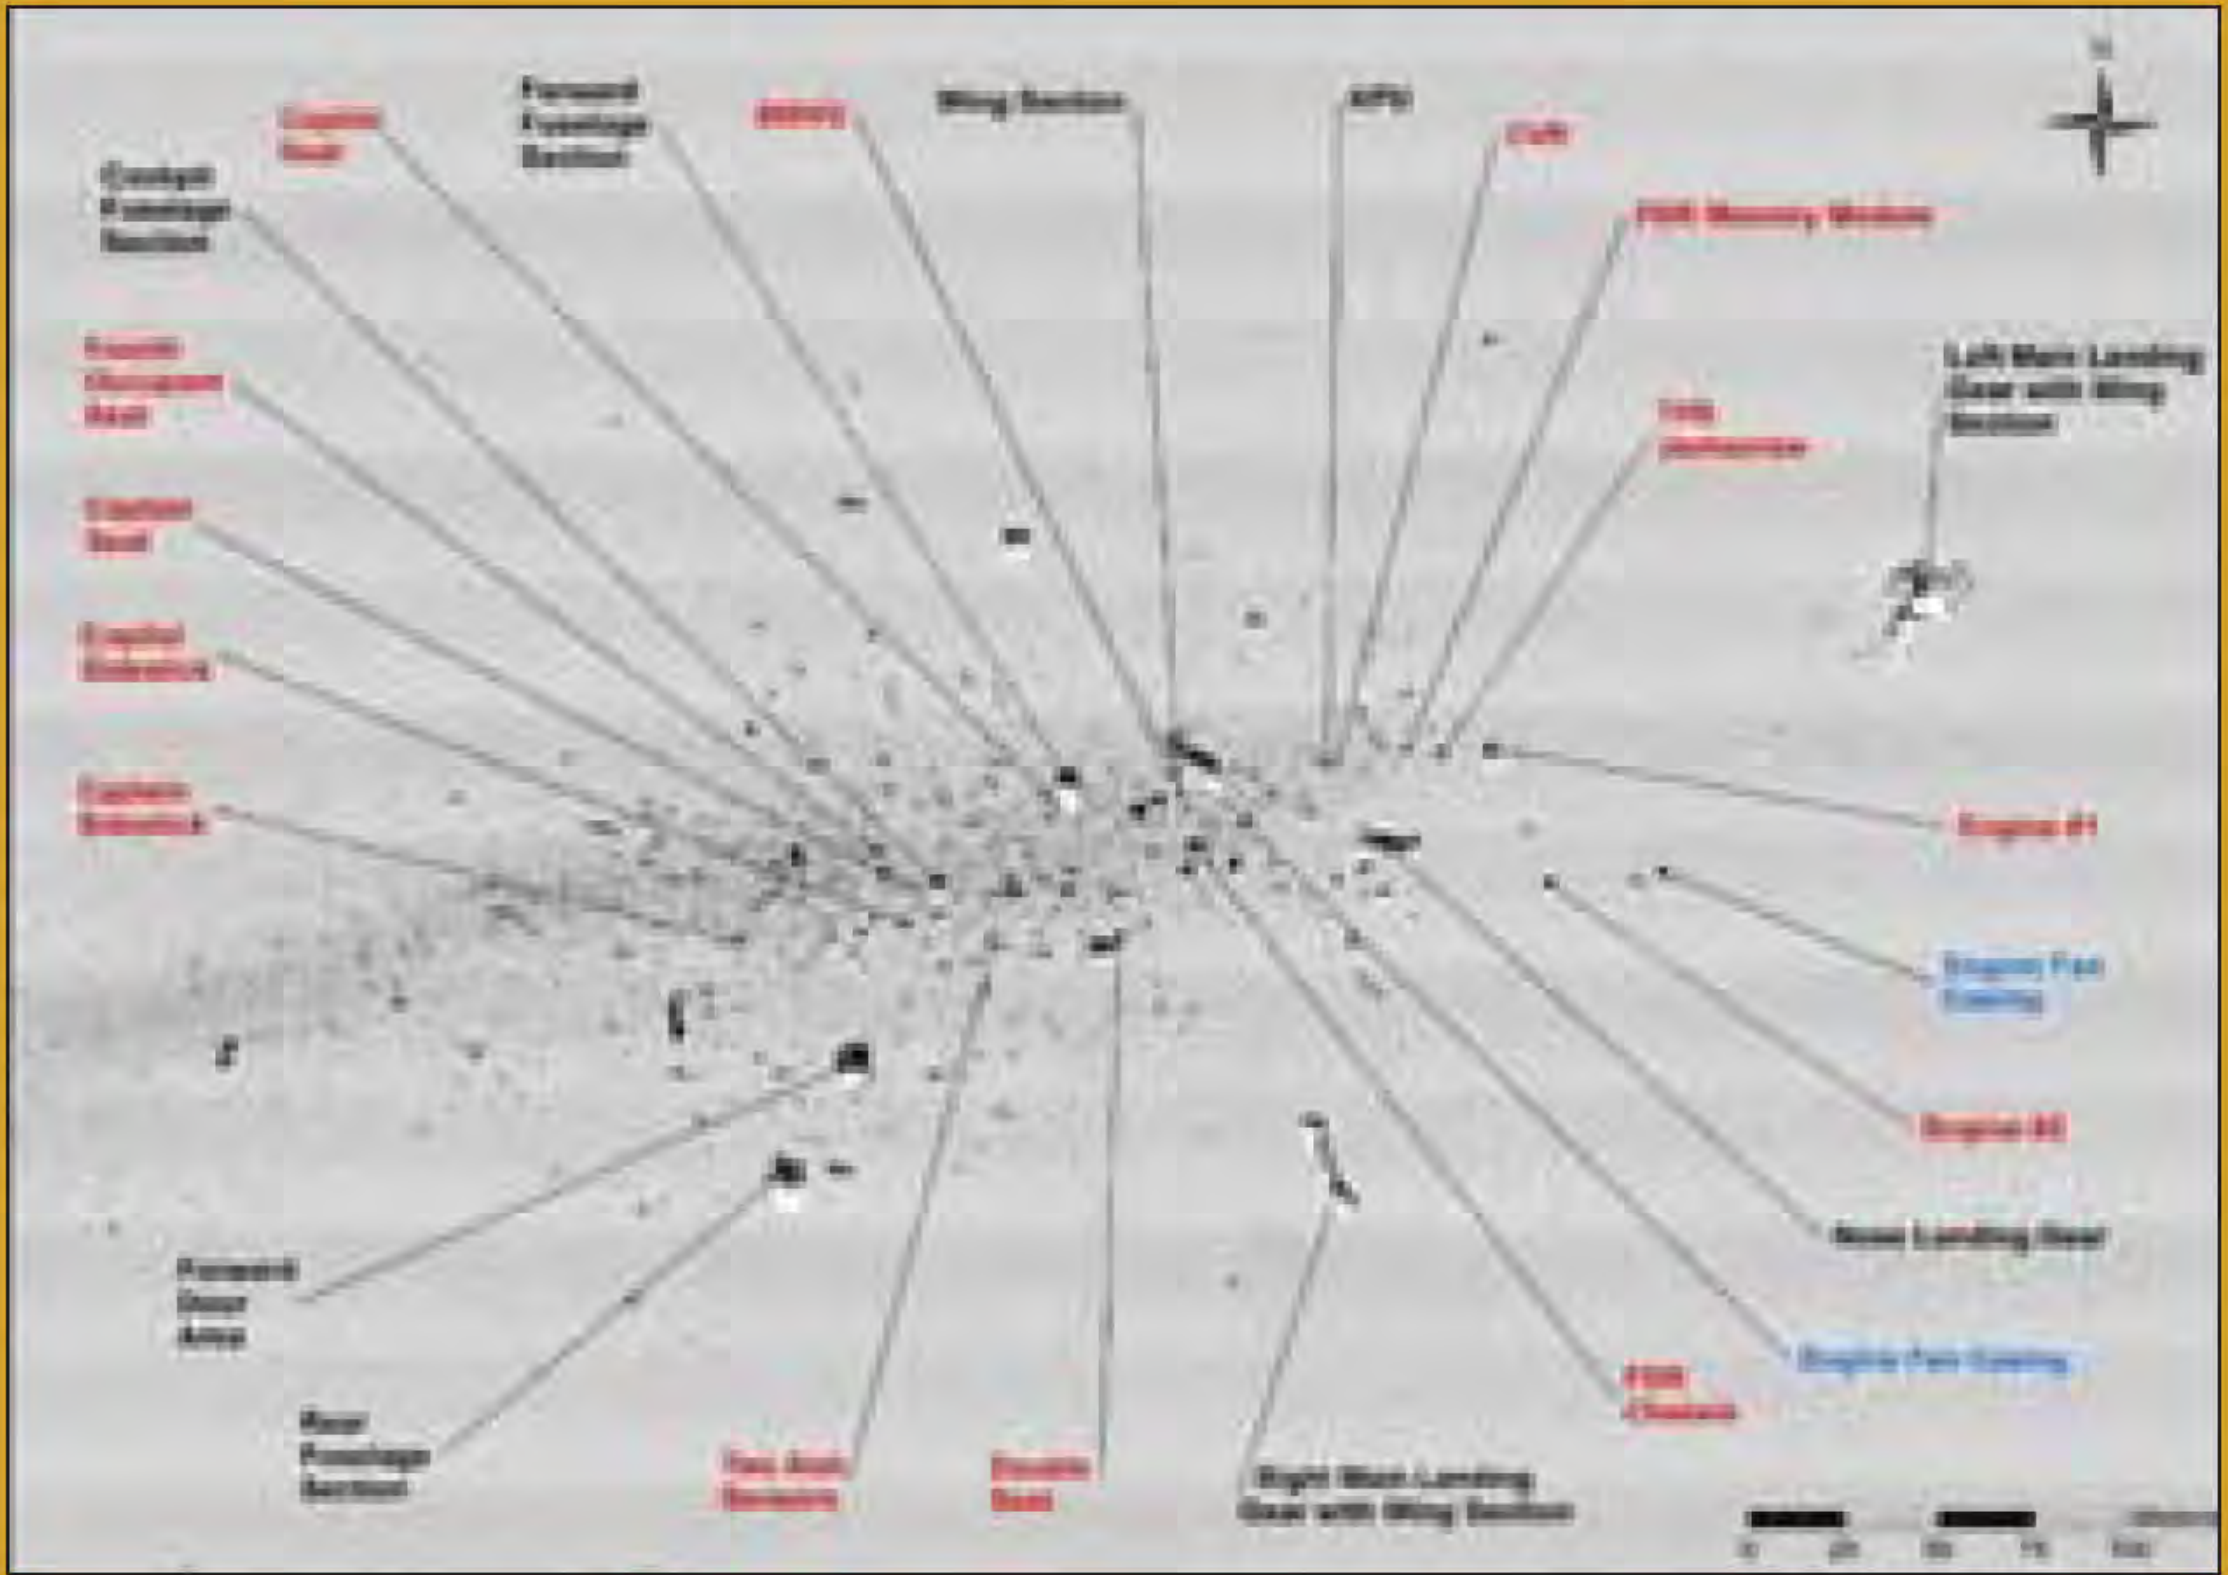
Top, one of the engines from AFR447 is retrieved from the Atlantic Ocean. Bottom, a map cataloging various aircraft components on the ocean floor.
