THE DOWNWIND TURN: AN OLD WIVES' TALE?

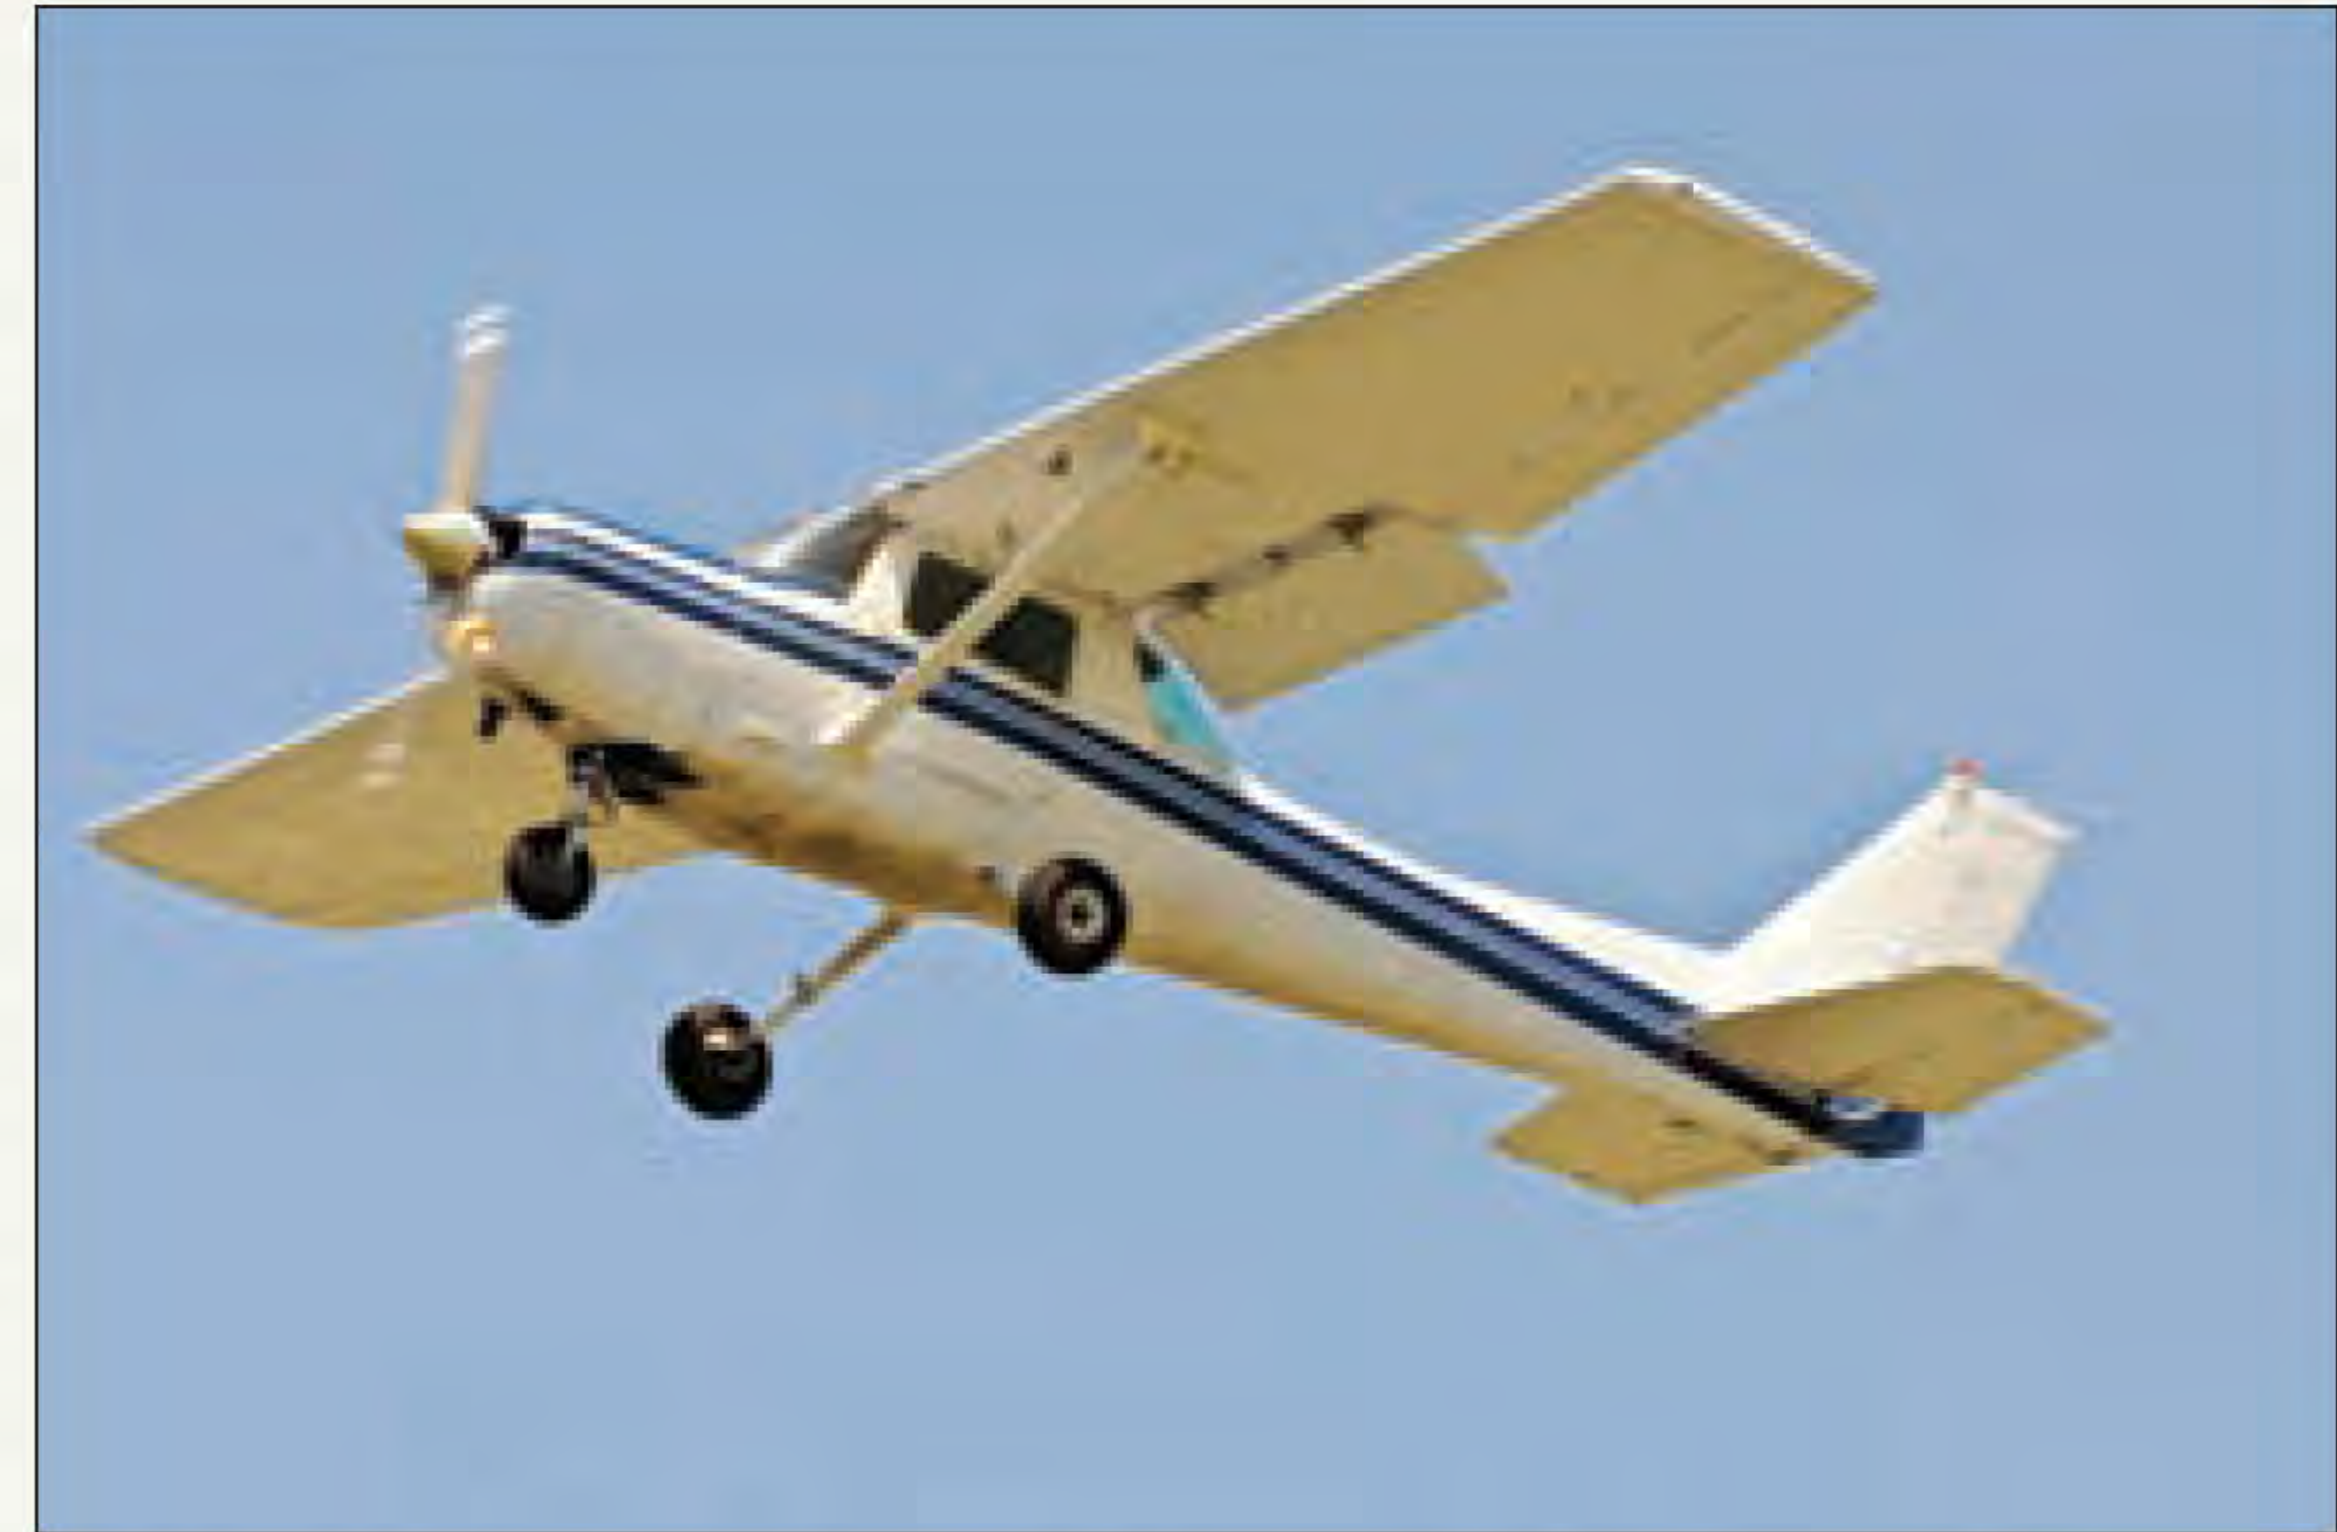
When abruptly turning from flight into a strong headwind or crosswind, we're actually forcing the airplane into a wind shear. Compounding the problem, a turn is performed by banking, which increases lift on the wing outside the turn and reduces it on the other. If, during that banked turn, the airplane encounters a gust from a direction other than the relative wind, the inside wing may stall.

A gentle turn from a steady headwind into a steady tailwind doesn't risk a wind shear encounter. But performing abrupt downwind turns in gusty conditions is tailor-made for a shear situation. Combine that maneuver with low airspeed and low altitude, and an unrecoverable stall/spin easily may result.
